# Inspection Report

1234 Main St  
Charleston SC 29401

**SC Property Inspections, LLC**

<b>Date:</b> 5/23/2018	<b>Time:</b>	<b>Report ID:</b> 2018/1/2-Main
<b>Property:</b> 1234 Main St Charleston SC 29401	<b>Customer:</b> John Smith	<b>Real Estate Professional:</b>

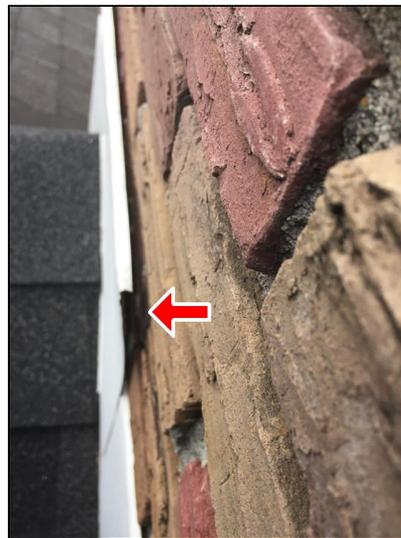
**1.1** The chimney flashing is loose and requires repair to avoid moisture penetration. Allow for repair of the chimney flashing as required.

1.1 Item 1(Picture) Loose Chimney Flashing

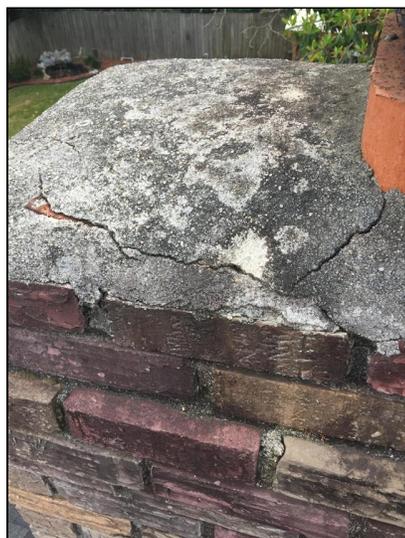
**1.2** The chimney requires re-pointing (replacing mortar joints) to remain water tight. The chimney crown is cracked and requires repair. Allow for further evaluation of the chimney and chimney flues by a licensed qualified contractor for repair options and costs.

1.2 Item 1(Picture) Cracked Chimney Crown

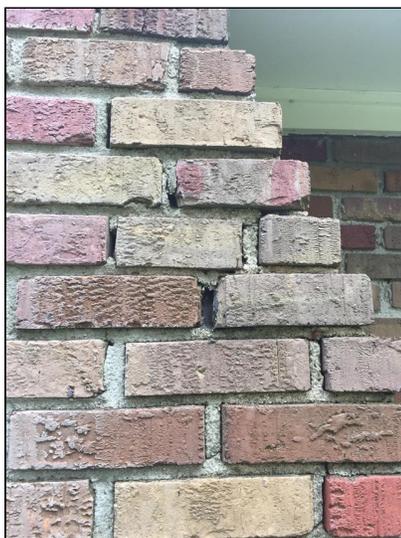
1.2 Item 2(Picture) Missing Mortar Joints

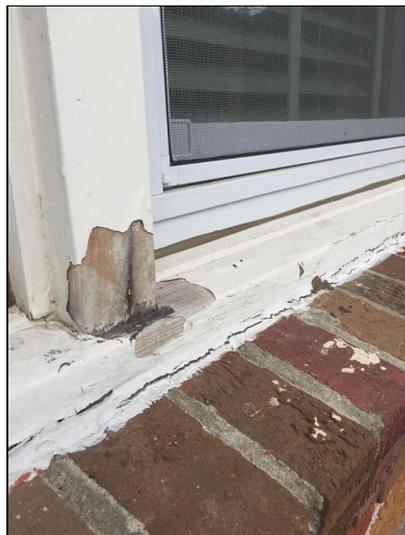
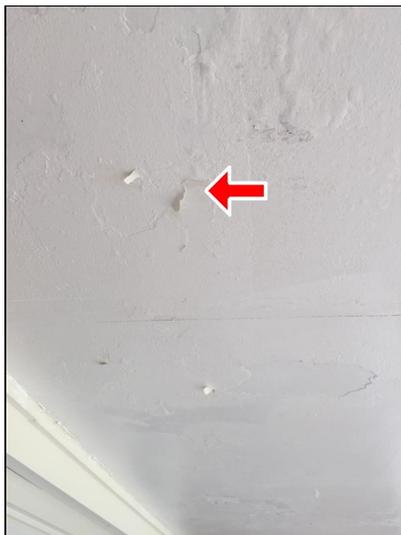
**2.0** Peeling paint was observed at the exterior at several areas including the window sills and the porch overhang. Allow for exterior painting as required.

2.0 Item 1(Picture) Peeling Paint

2.0 Item 2(Picture) Peeling Paint

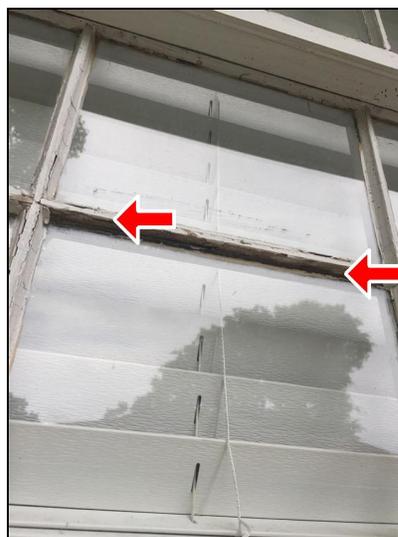
**2.2** The old windows are in poor condition. Glazing improvements and painting is recommended. Replacement windows may be the best long term approach. Allow for repair or replacement of the old windows as needed.

2.2 Item 1(Picture) Missing Window Glazing

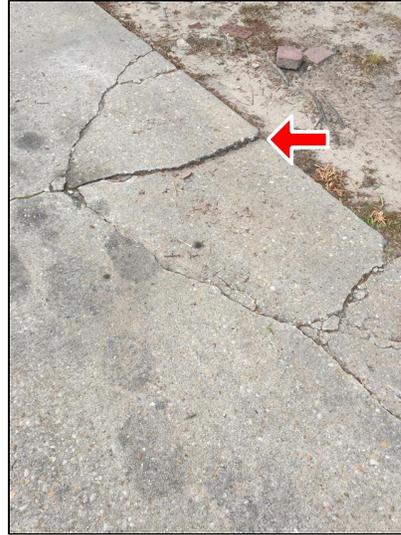
**2.4** The driveway has settled to the point that it is a tripping hazard. Allow for repair to the concrete driveway as necessary.

2.4 Item 1(Picture) Driveway Settlement

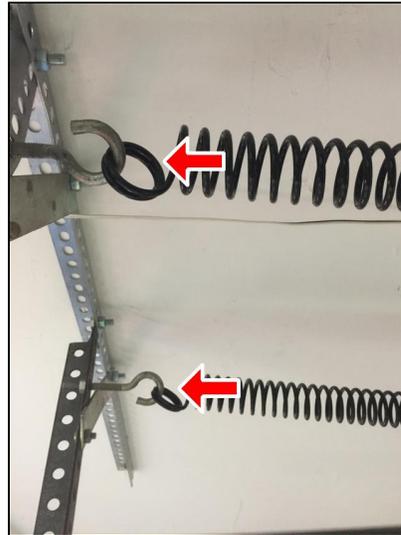
**3.3** It is recommended that safety cables be installed through the overhead garage door springs. This will increase the level of safety when operating the door in case of a broken spring. Allow for the installation of a safety cable.

3.3 Item 1(Picture) Missing Safety Cables

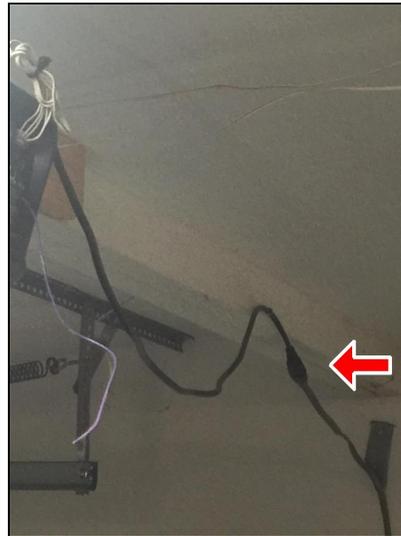
**3.5** The overhead garage door openers are installed with an extension cord. Extension cords should not be used as permanent wiring. Allow for repairs as needed.

3.5 Item 1(Picture) Garage Door Opener Extension Cord

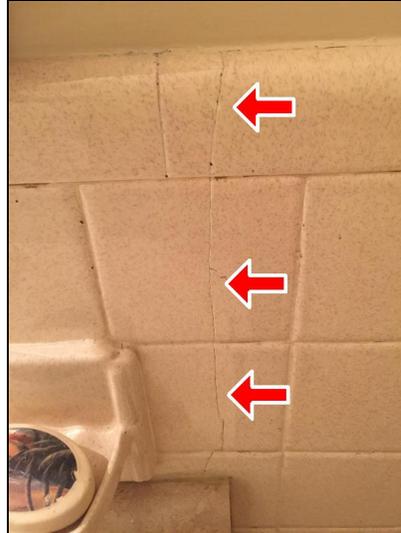
**4.1** Cracked wall tile was noted at the hall bathroom. Allow for replacement of the cracked tile as needed.

4.1 Item 1(Picture) Cracked Tile

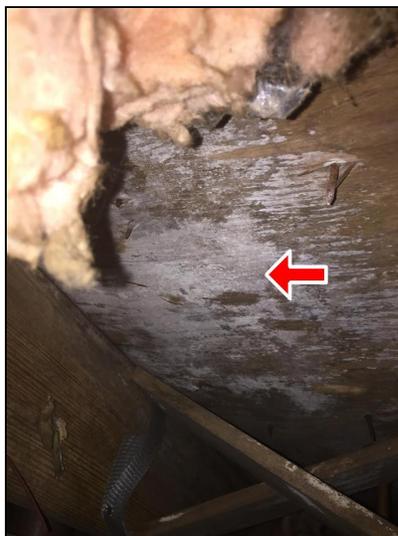
**5.0** Signs of fungi growth is present on the floor system in crawlspace in several areas. We did not inspect, test or determine if this growth is or is not a health hazard. The underlying cause is moisture. I recommend you contact a mold inspector or expert for investigation or correction if needed.

5.0 Item 1(Picture) Possible Fungal Growth

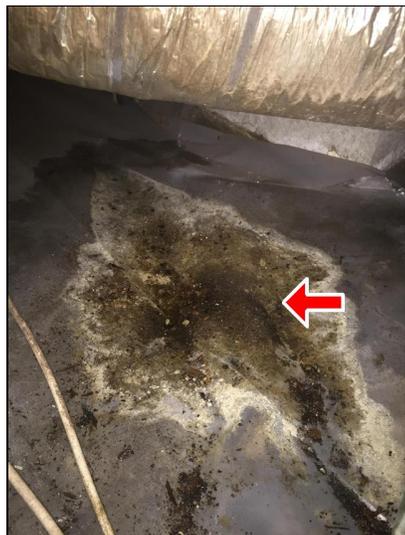
**6.0** The waste piping from the hall bathroom leaks into the crawl space. Allow for repair to the waste piping by a licensed qualified plumber.

6.0 Item 1(Picture) Standing Water From Waste Pipe Leak

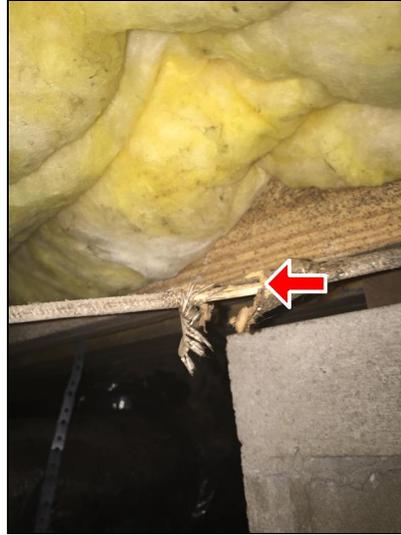
**7.2** Frayed wiring was noted in the crawl space. The damaged wiring requires replacement by a licensed electrician.

7.2 Item 1(Picture) Frayed Wiring

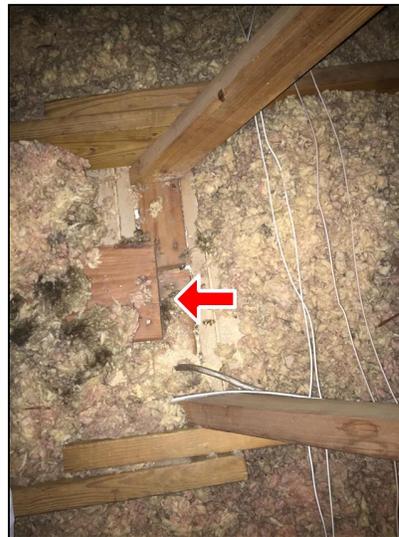
**9.0** Gaps in the attic insulation should be filled for optimal performance. Allow for the addition of insulation where missing.

9.0 Item 1(Picture) Missing Insulation

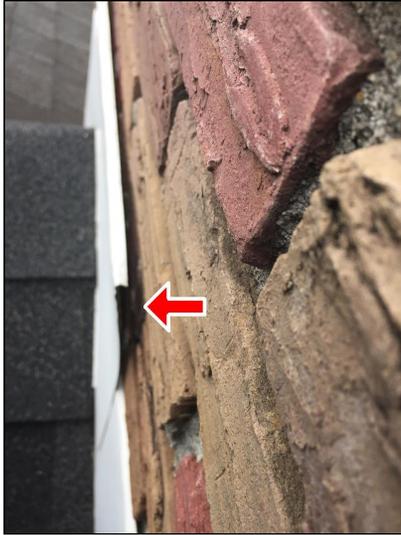
The chimney flashing is loose and requires repair to avoid moisture penetration. Allow for repair of the chimney flashing as required.

1.1 Item 1(Picture) Loose Chimney Flashing

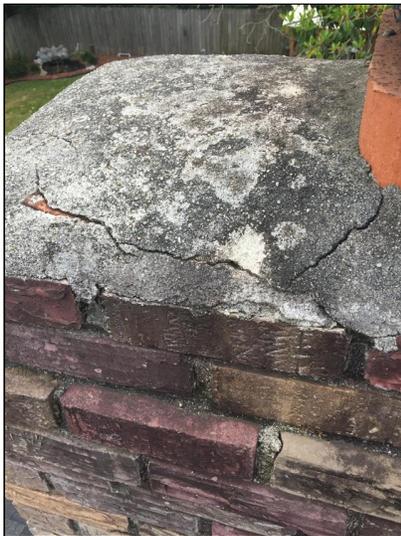
The chimney requires re-pointing (replacing mortar joints) to remain water tight. The chimney crown is cracked and requires repair. Allow for further evaluation of the chimney and chimney flues by a licensed qualified contractor for repair options and costs.

1.2 Item 1(Picture) Cracked Chimney Crown

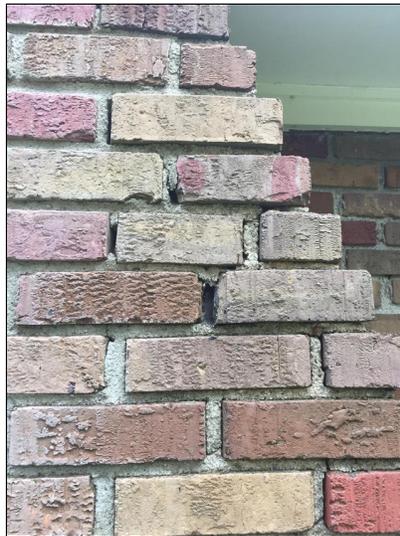
1.2 Item 2(Picture) Missing Mortar Joints

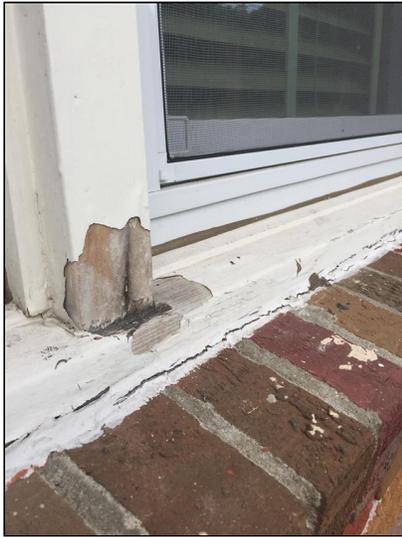
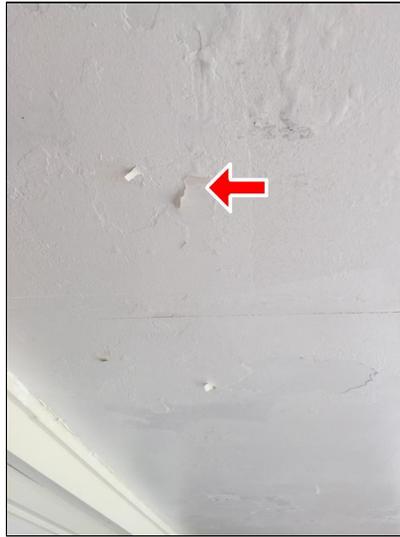
Peeling paint was observed at the exterior at several areas including the window sills and the porch overhang. Allow for exterior painting as required.

2.0 Item 1(Picture) Peeling Paint

2.0 Item 2(Picture) Peeling Paint

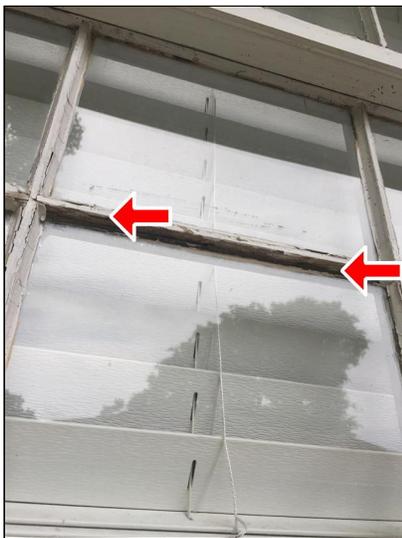
The old windows are in poor condition. Glazing improvements and painting is recommended. Replacement windows may be the best long term approach. Allow for repair or replacement of the old windows as needed.

2.2 Item 1(Picture) Missing Window Glazing

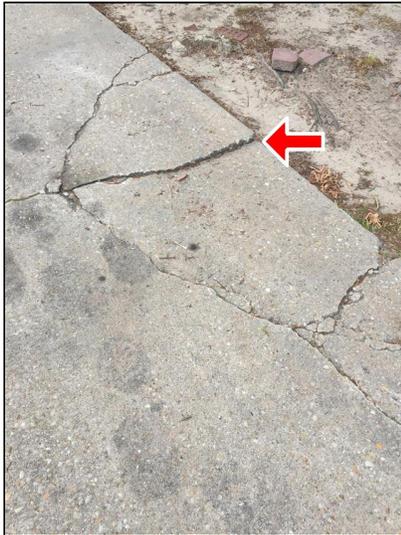
The driveway has settled to the point that it is a tripping hazard. Allow for repair to the concrete driveway as necessary.

2.4 Item 1(Picture) Driveway Settlement

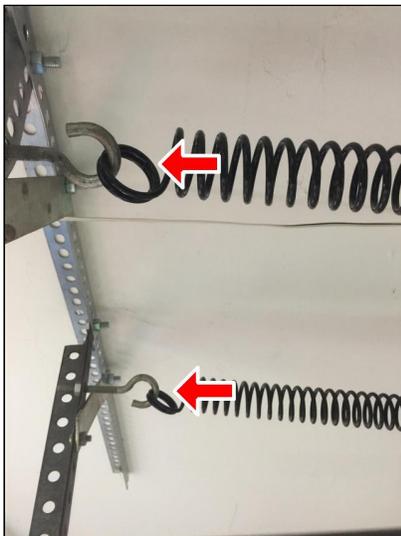
It is recommended that safety cables be installed through the overhead garage door springs. This will increase the level of safety when operating the door in case of a broken spring. Allow for the installation of a safety cable.

3.3 Item 1(Picture) Missing Safety Cables

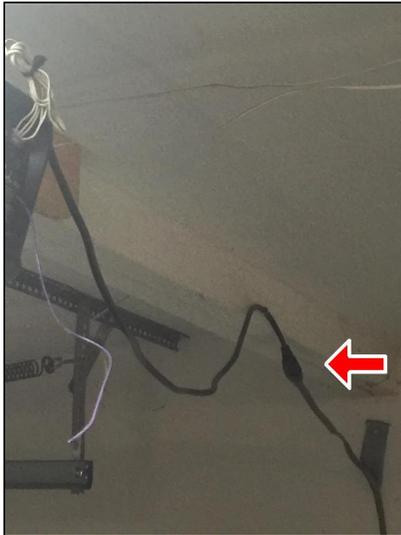
The overhead garage door openers are installed with an extension cord. Extension cords should not be used as permanent wiring. Allow for repairs as needed.

3.5 Item 1(Picture) Garage Door Opener Extension Cord

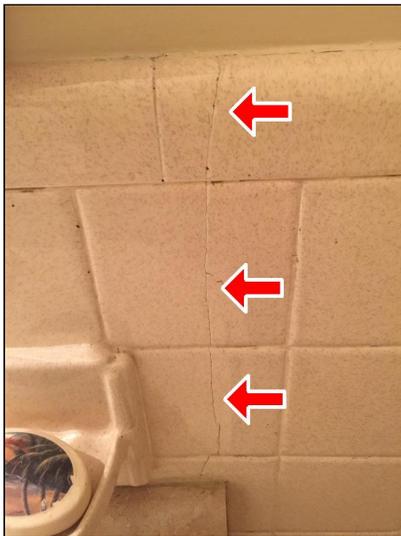
Cracked wall tile was noted at the hall bathroom. Allow for replacement of the cracked tile as needed.

4.1 Item 1(Picture) Cracked Tile

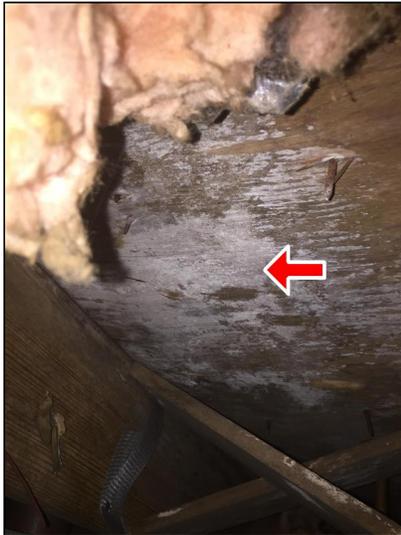
Signs of fungi growth is present on the floor system in crawlspace in several areas. We did not inspect, test or determine if this growth is or is not a health hazard. The underlying cause is moisture. I recommend you contact a mold inspector or expert for investigation or correction if needed.

5.0 Item 1(Picture) Possible Fungal Growth

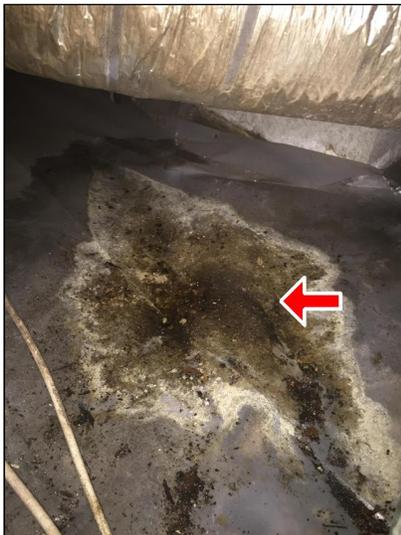
The waste piping from the hall bathroom leaks into the crawl space. Allow for repair to the waste piping by a licensed qualified plumber.

6.0 Item 1(Picture) Standing Water From Waste Pipe Leak

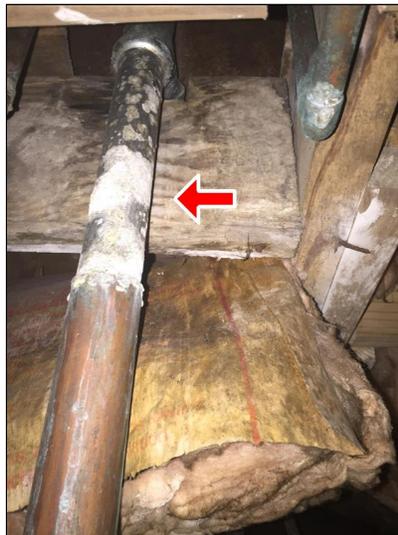
6.0 Item 2(Picture) Leaking Waste Piping

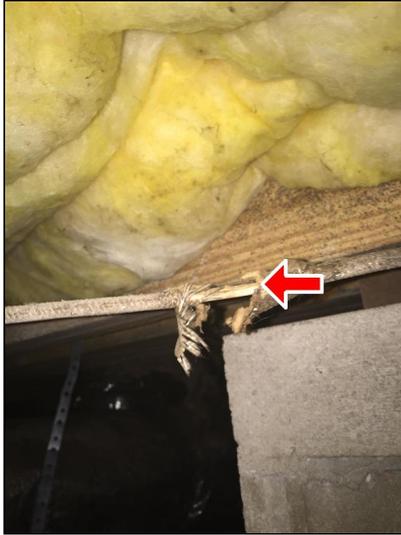
Frayed wiring was noted in the crawl space. The damaged wiring requires replacement by a licensed electrician.

7.2 Item 1(Picture) Frayed Wiring

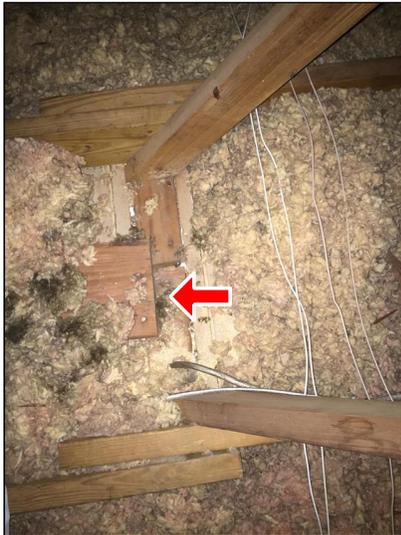
Gaps in the attic insulation should be filled for optimal performance. Allow for the addition of insulation where missing.

9.0 Item 1(Picture) Missing Insulation
